### IC695CPE400-ABAK<sup>1</sup> IC695CPL410-AAAB<sup>1</sup> 1.2GHz 64MB Rackless CPUs

**IC695CPE400**

**Introducing the IC695CPL410**

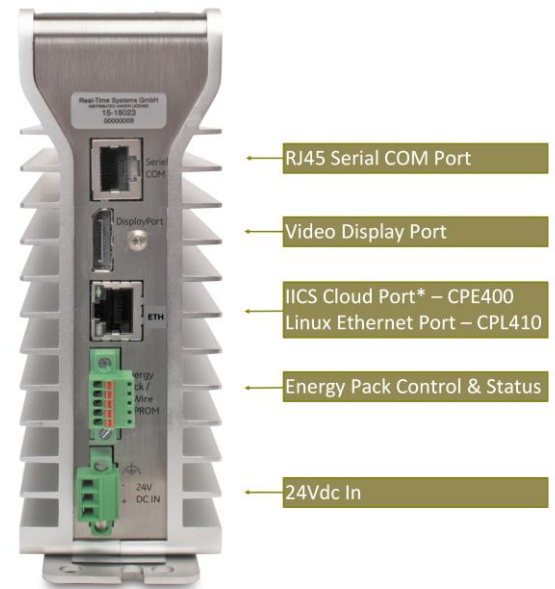
**Figure 2: Underside Ports & Connectors**

\* The IICS Cloud Port is labeled "EFA" instead of "ETH" on some versions of the CPE400.

- Supports four independent 10/100/1000 Ethernet LANs. Three are located on the front panel, as shown in Figure 1. LAN1 attaches via the upper, dedicated RJ 45 connector. LAN2 and LAN3 each attach via a pair of internally-switched RJ 45 connectors. The fourth LAN, labeled EFA (Embedded Field Agent), is located on the underside (Figure 2), and is specifically used for Field Agent connectivity.

- The Embedded PLC supports Serial IO protocol using the Serial COM port located on the underside (Figure 2) of the controller.
- The rackless CPUs are secure by design, incorporating technologies such as Trusted Platform Modules, secure boot, and encrypted firmware updates.

<b>Display Port is not operational</b>	<p>The Display port, located on the underside of the CPE400 and CPL410 (Figure 2) is not operational.</p>
<b>USB Ports</b>	<p>The CPE400's USB ports are reserved and not available for use. The CPL410's left USB port is assigned to Linux. The right USB port is reserved.</p>
<b>Micro SD Card</b>	<p>The Micro SD Card Slot is reserved and not available for use.</p>
<b>Serial IO Protocol</b>	<p>Serial IO Protocol is supported on the CPE400 effective with firmware release 9.40 and on the CPL410 effective with release 9.55.</p>
